Manhole Inspection Summary

Manhole # S31YY1014MH

Location Address: **5304 SAINT ALBANS WAY**

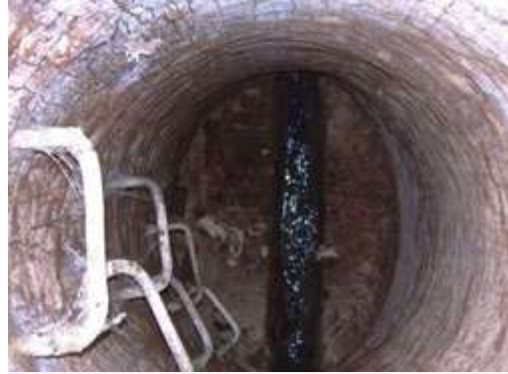
Top View

Surcharge ☒ **Evidence Of Surcharge** Depth: **1** (ft.) ☐ Active Surcharge Present

Evidence of surcharge - Bench debris.
Channel debris.

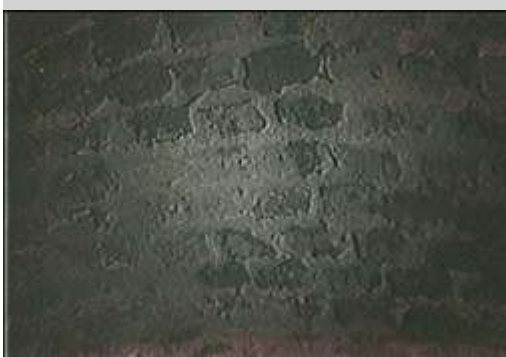
Defect

Barrel infiltration.

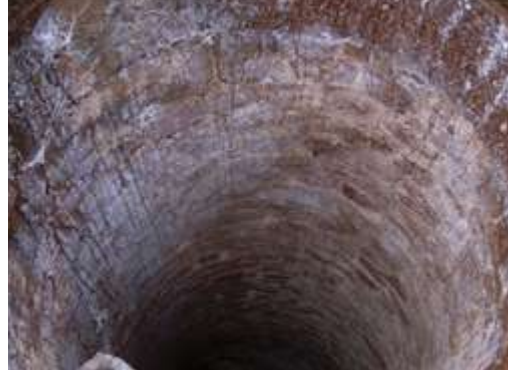
Defect

Frame leaks. Adjustment deterioration
and infiltration. Corbel and Barrel
infiltration.

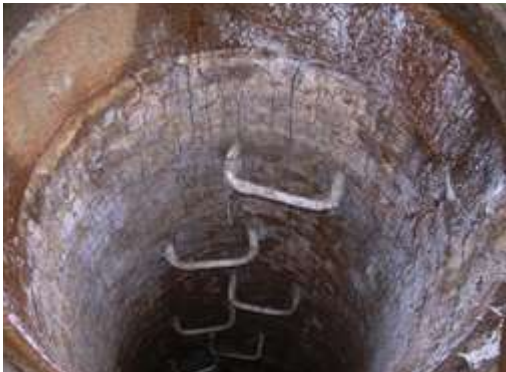
Defect

Frame leaks. Adjustment deterioration
and infiltration. Corbel and Barrel
infiltration - other side.

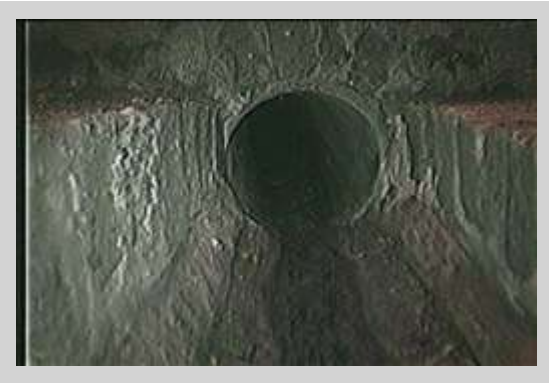
8 in. Circular Gravity Sewer Pipe Out @ 12 O'Clock

Infiltration: **Evidence** Pipe Seal Cond: **Cracked**

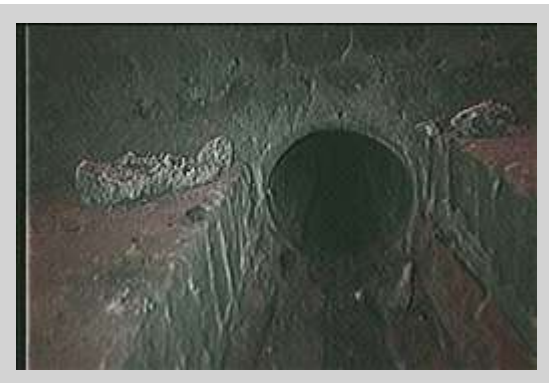
8 in. Circular Gravity Sewer Pipe In @ 6 O'Clock

Channel cracks.
